20/20 HOME INSPECTIONS

HOME INSPECTION REPORT

181 Gloucester Grove

April 30th 2022

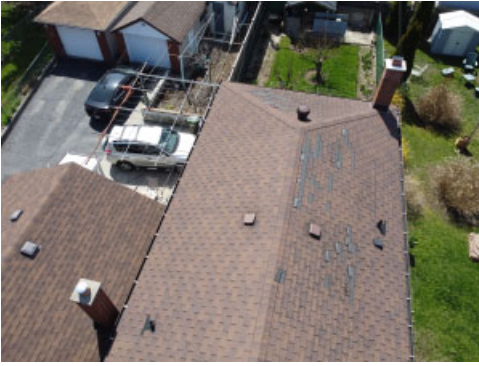
Roofing Image

Shingles are badly worn on the south and west surfaces of the roof. Expect to replace within 1 year

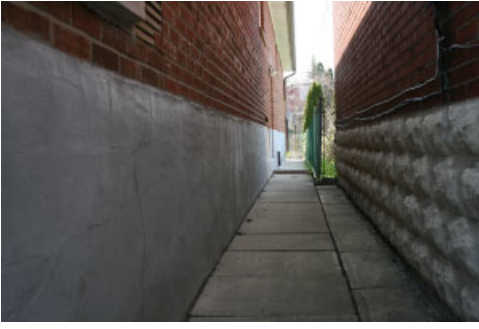
Exterior Image

Walkway slopes towards foundation wall on west side of house.

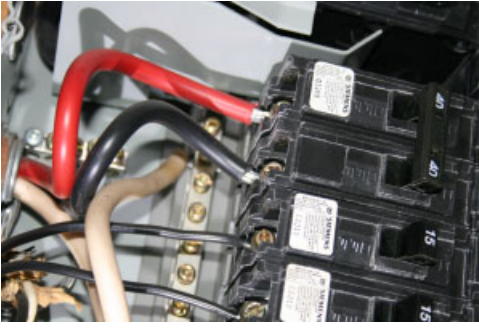
Electrical Image

Aluminum wiring is the main wiring

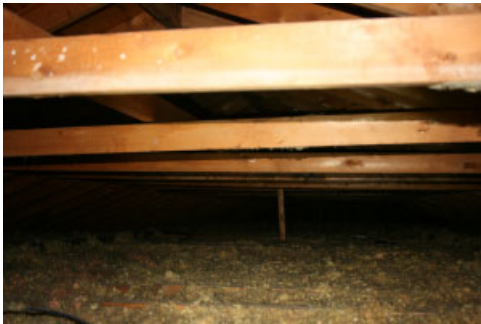
Interior Image

Low attic insulation
